DOCUMENTATION, ANALYSIS, AND INTERPRETATION OF
THE INTERIOR FINISHES OF FRANK LLOYD WRIGHT'S HELLER HOUSE

Zana Cecelia Wolf

A THESIS

Historic Preservation

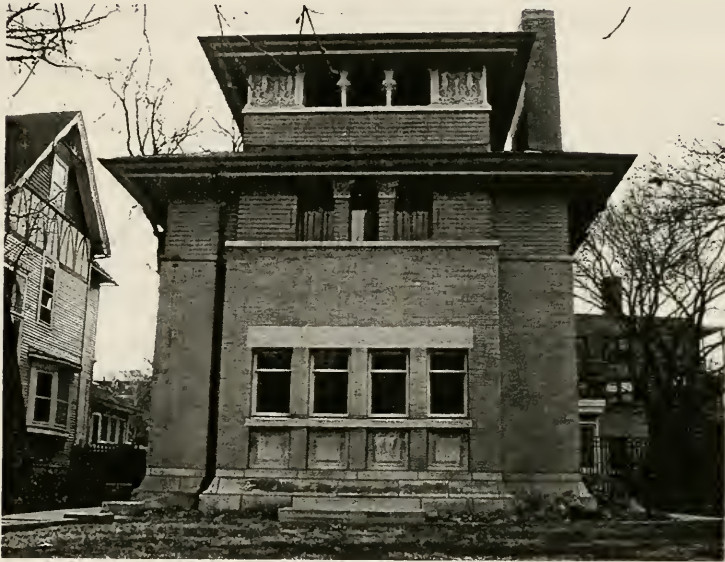
Figure 1.1 Isidore Heller House, East façade,
5132 Woodlawn Avenue, Chicago.
Photograph by the author, 1999.

In the Heller House, Wright designed a house to conform to the restraints of a deep but fairly narrow city lot. The majority of the exterior of the house is executed in buff and gray Roman brick; the first story is composed of buff-colored brick while the second story includes both buff and gray brick. (Figure 1.1.) Mortar joints are buff colored in the vertical and gray in the horizontal, emphasizing the horizontality of the design. Unique features of the Heller house exterior include the third story sculptural frieze of draped female figures by Richard Bock, a well-known Chicago sculptor. The figures were modeled after Wright's design for the title page of *The Eve of St. Agnes* which was published in 1896. The design of the winged Beaux Arts female figures was simplified slightly in the translation from the title page to the Heller House frieze, probably due to the nature of the material, which was hand-modeled and cast plaster.¹ (Figure 1.7.) It is in this exterior detail that the influence of Louis Sullivan can best be seen.

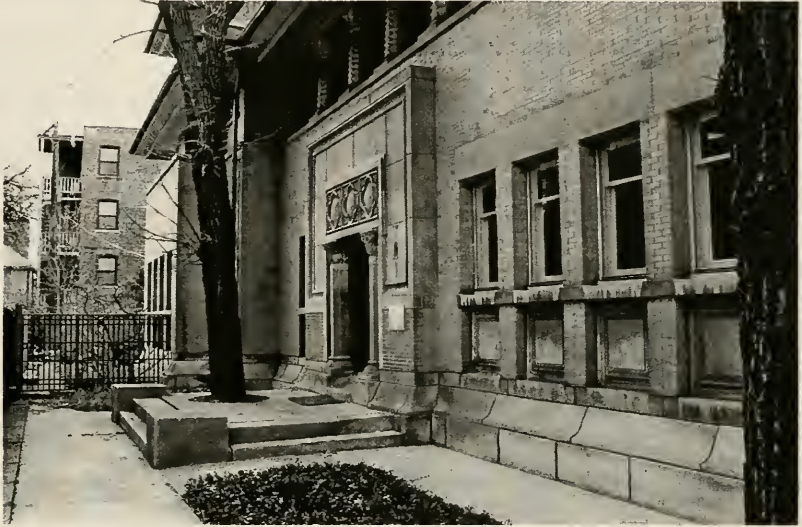
Figure 1.2 Entrance to the Heller House, South elevation.
The loggia is visible on the second level.
Photograph by the author, 1999.

The overall appearance of the house from the street is rather simple and severe with its neutral colored bricks, and basic geometries. Upon closer inspection, the austere street façade unfolds with the concentrated elaborate details of the Romanesque columns of the entry, the frieze of maidens, and the beautifully colonnaded second-story loggia.

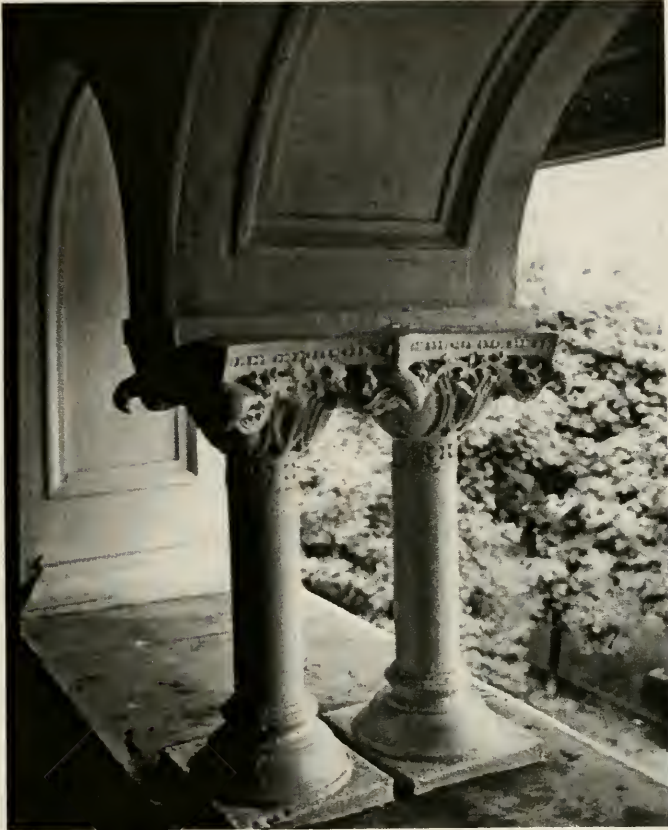
Figure 1.6 Colonette on the third story.
Courtesy of Judith Bromley, 1999.

(Figure 2.) Above the entrance is a piazza, embellished with a row of elaborate plaster colonettes supporting the deep cornice and the third story.³ (Figure 6.)

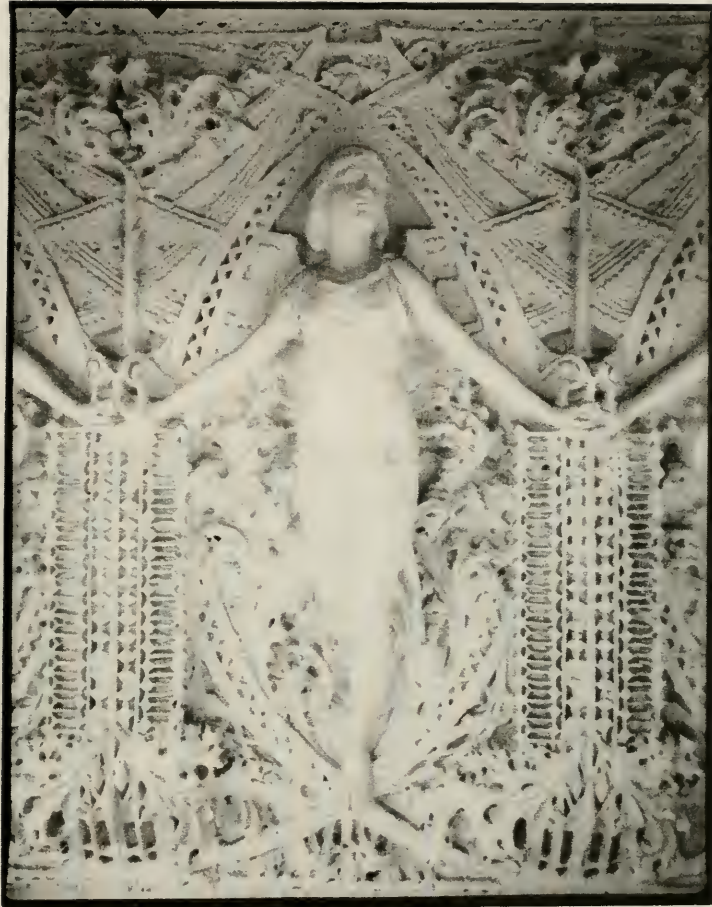
Figure 1.7 Detail of the maiden from the Heller House Frieze.
Sculpted by Richard Bock, 1897.
Photograph Courtesy of Judith Bromley, 1998.

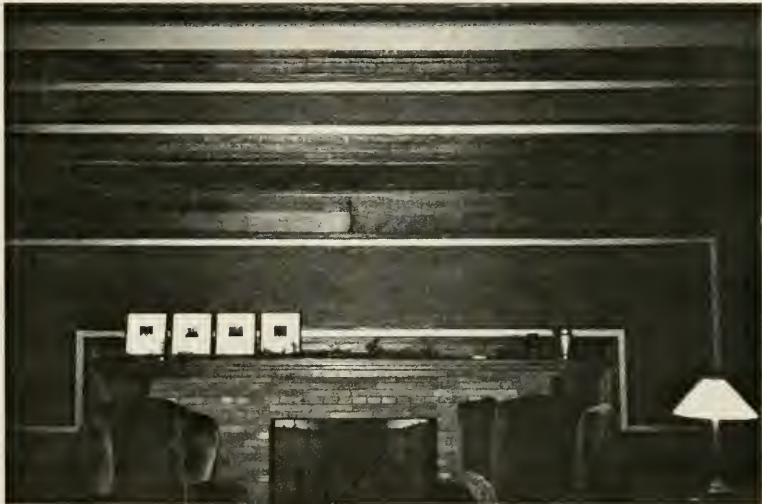
Figure 1.8 North side of drawing room where fire place and wood bands are visible. Photograph by the author, 1999.

The Heller House interior was originally trimmed in quarter-sawn oak.⁹ The primary rooms on the first floor - the drawing room, dining room, and hall - have oak woodwork that frames the ceiling and wall spaces. The windows on the first floor are one-over-one sash finished in a dark green paint on the interior. The living room has a brick fireplace framed in oak, and built-in bookcases with delicate filigree work on their sides. Wright's original drawing included brass light standards that were subsequently removed but the outlines of the bases remain on the floor in the living room.¹⁰ (Figure 1.8.)

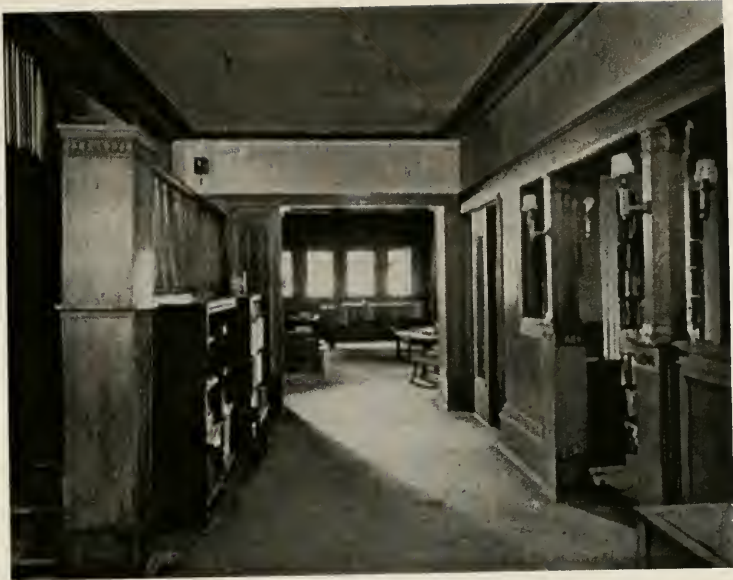
Figure 1.9 Historic photograph of hall c. 1950.

The long, broad center hall includes the stairs to the second floor finished with closely spaced, oak balustrades. The dining room has a brick fireplace framed in oak, with open cabinets on either side and small wood columns above where light standards are set. The servants' areas--the pantry, kitchen, and back hall of the first floor --are all finished in pine. (Figures 1.9, 1.10.)

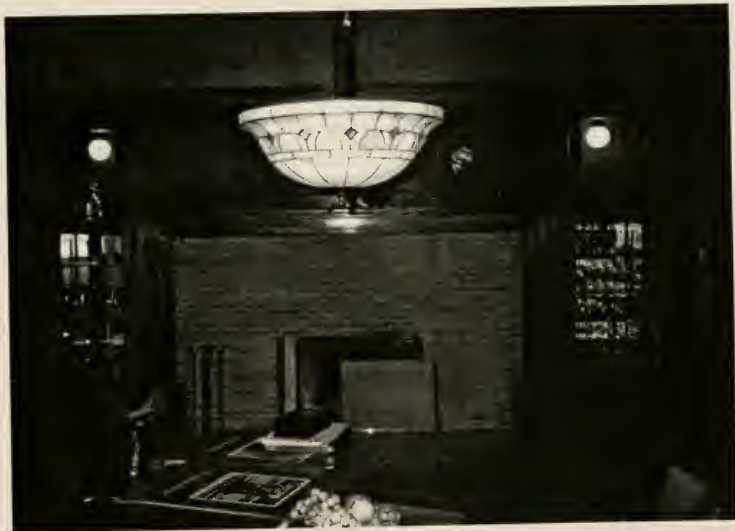
Figure 1.10 Dining room north side where fireplace and cabinets are visible. Photograph by the author, 1999.

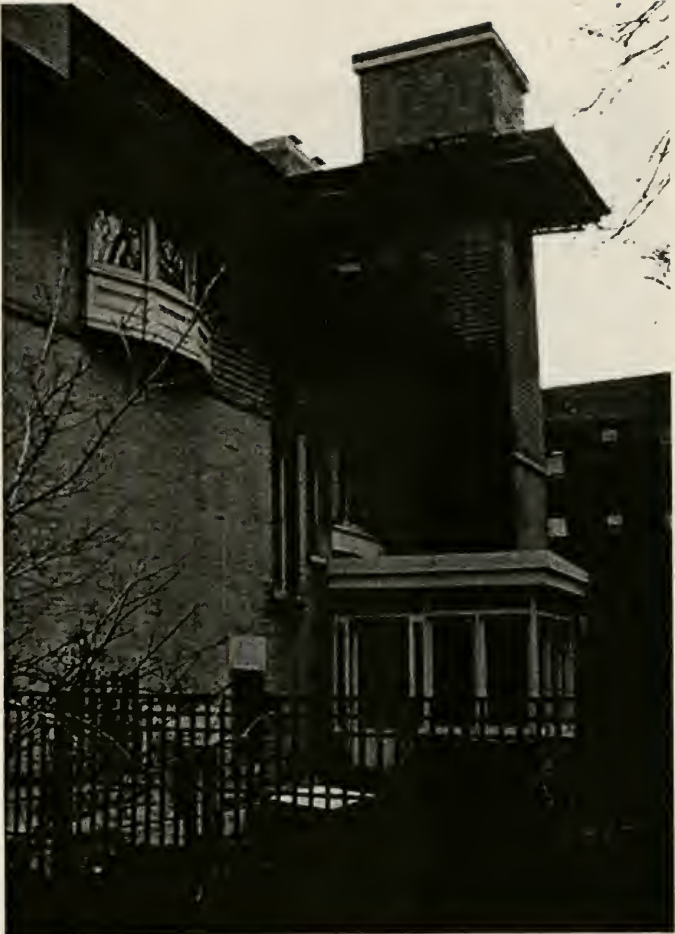
Figure 1.12 Heller House, north façade.
Porch and elevator shaft are visible. Photograph by the author, 1999.

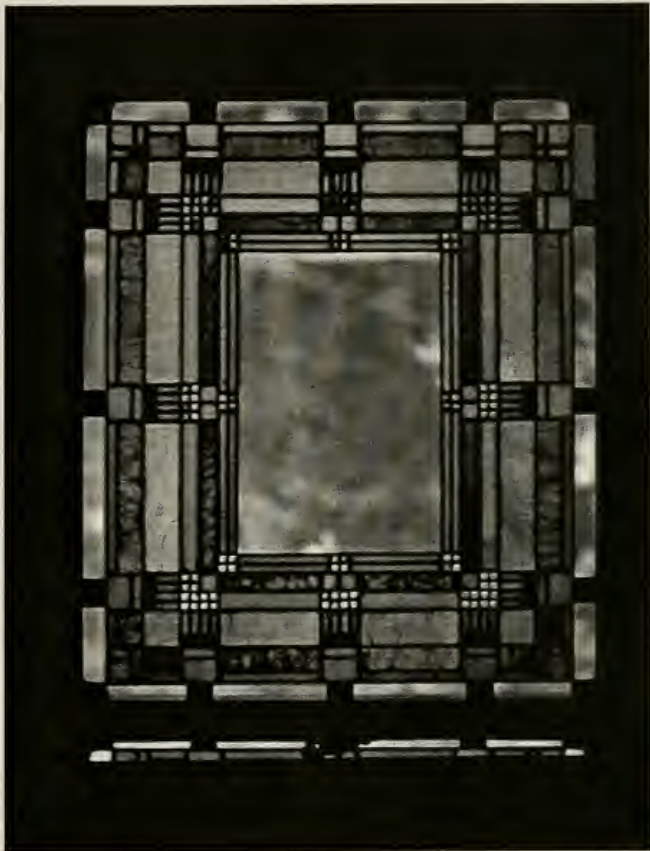
Figure 1.13 Art glass window in stair hall, north elevation.
Photograph courtesy of Judith Bromley, 1999.

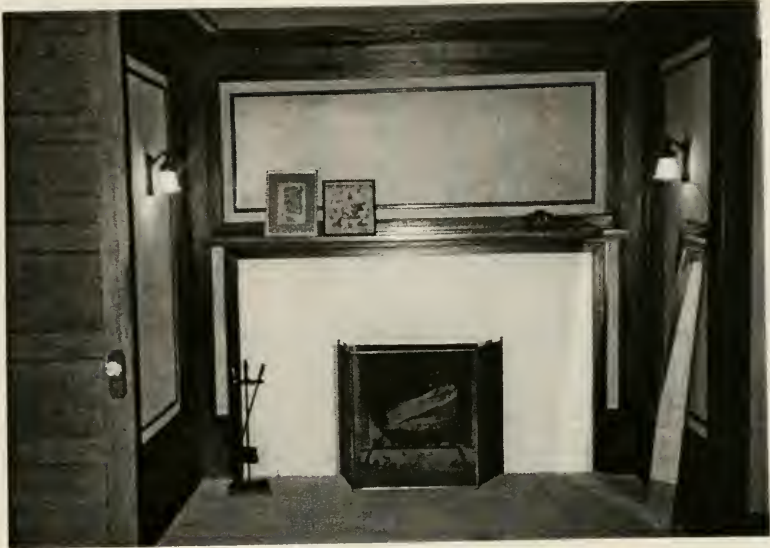
Figure 1.15 Restored Fireplace in master bedroom.
Photograph by the author, 1999.

The main stairway is illuminated by large art glass windows. (Figure 1.13.) The second floor includes a long hallway leading to four bedrooms and a sewing room. The master bedroom, on the east end of the house, includes a recently restored fireplace that was discovered by the current owners during their renovation of the adjacent bathroom. (Figures 1.15, 1.16.) This fireplace shares the stack with the living room fireplace. There is another fireplace of light buff brick located in the southwest bedroom, above the dining room fireplace.

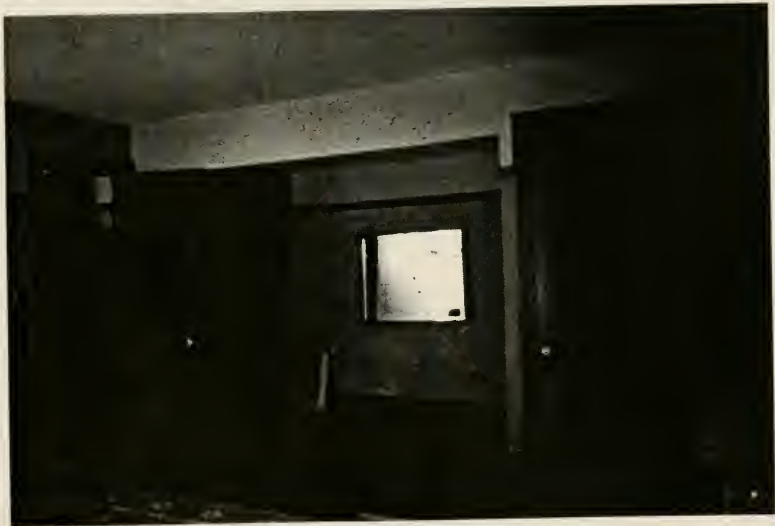
Figure 1.16 Master Bedroom before Fireplace was uncovered and restored.
Photograph by Judith Bromley, 1996.

The present owners exhibit a great deal of respect for Wright's design and unending curiosity regarding original elements of the house that are missing or have been obscured for years. In five years, they have carefully restored a bathroom, investigated original paint colors, and restored the master bedroom fireplace that had been walled up for many years.

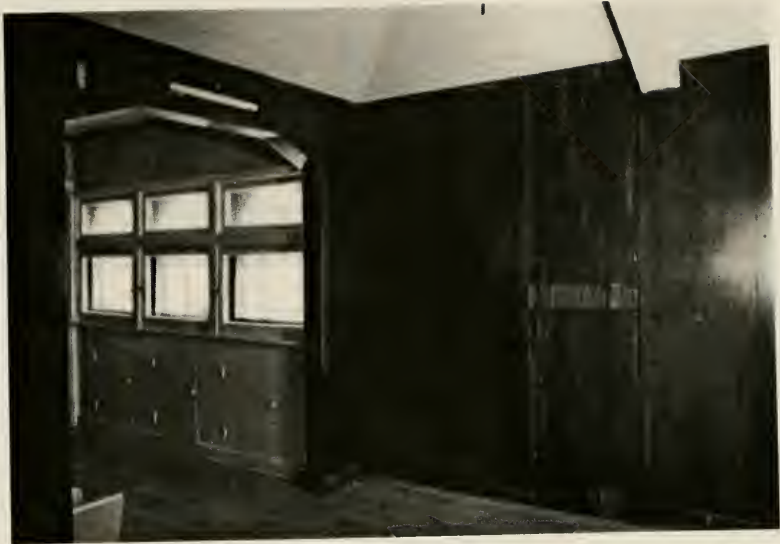
Figure 1.17 Attic play room, north elevation.
A small area of the original bead board is uncovered.
Photograph courtesy of Judith Bromley.

The third story of the Heller house originally had servant's bedrooms and a children's play room and now includes three bedrooms, one bathroom, a kitchen, a dining area, and a long room stretching eastward toward Woodlawn Avenue. (Figure 1.17.) The dining area was added sometime after the original construction and encompasses part of the original play room. The alterations were most likely made during the occupation of the Watsons, because their parents moved into the third story. Much of the original green paint over rough sand-float plaster remains in this story.

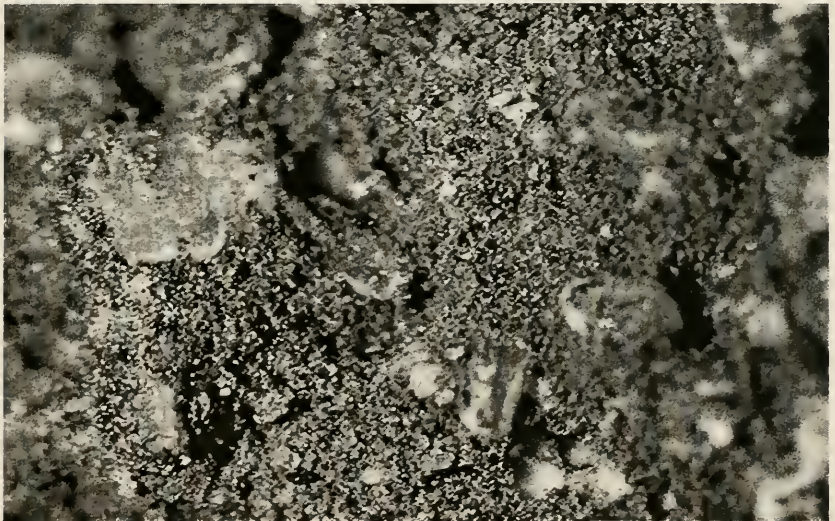
Figure 4.7 Photomicrograph of surface of sample 1.04-1 from the living room. The original layer is coarsely textured and the various pigments are visible. 50X.

Microscopic inspection revealed that the original paint layers from the first floor (living room, dining room, hall, vestibule, reception room) can be described as matte, coarsely pigmented, and very heterogeneous. (Figure 4.6,4.7.) Therefore, in the original paint layers in cross section, groups of pigments are visible, the layers appear coarse, and the color of the paint layer varies across the sample. Samples from the sewing room on the second floor and the attic shared the same characteristics. The visible characteristics of these paint samples suggested that they were distemper paints instead of oil or wax. The original paint layers in such rooms as the first floor bathroom and the second floor bedrooms, were glossy and more homogenous in appearance. (Figure 4.8.)

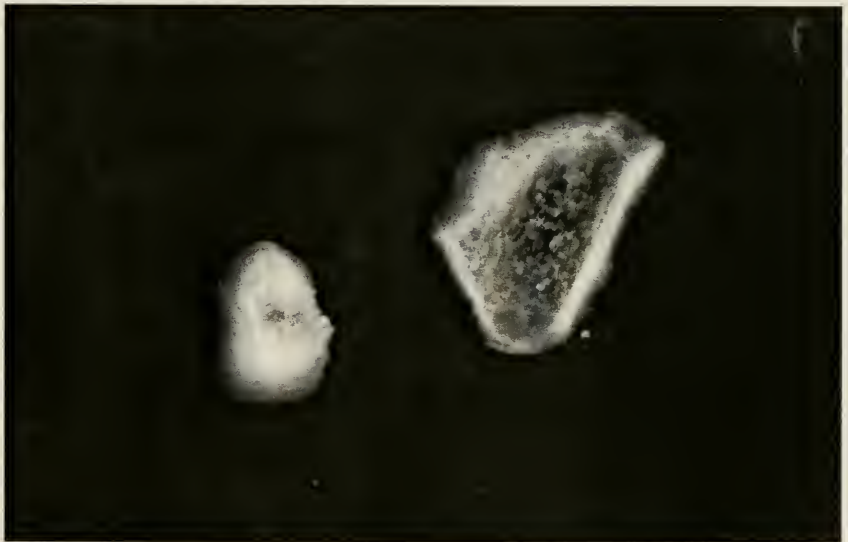
Figure 4.17 Reference sample of quartz. Note resemblance to sample 1.04-1 above. Magnification 100X.

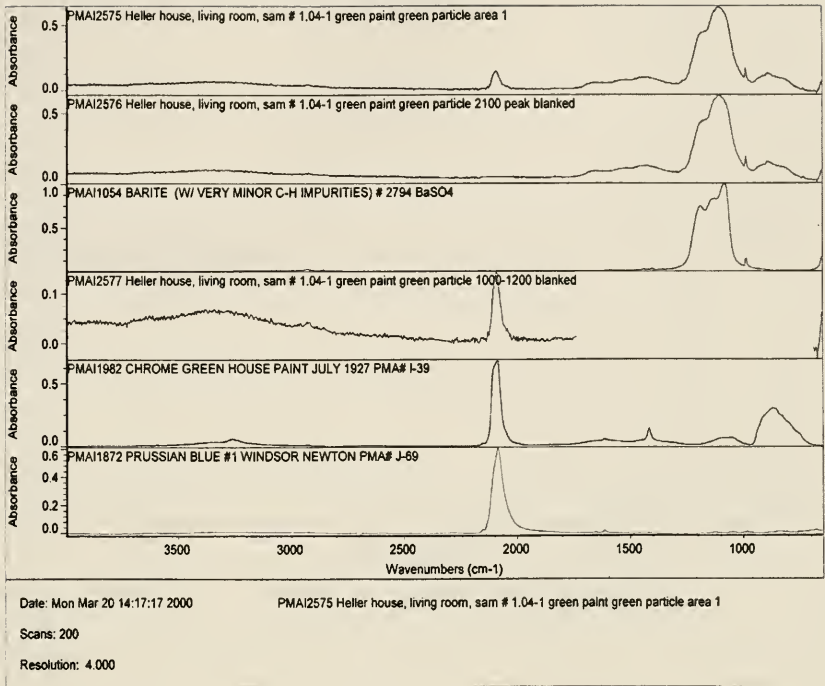
Figure 4.20 FTIR Spectra of Sample 1.04-1 indicating the presence of barite and chrome green pigment in the original paint layer in the living room.

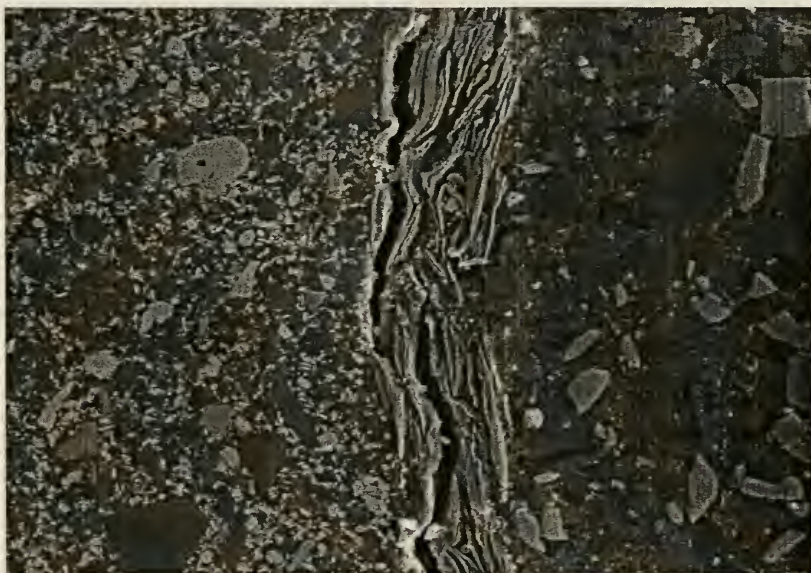
Figure 4.27 Scanning Electron Image of metallic layer in sample 1.04-6 from the living room metallic finish. The center line is the location of the metallic finish in the sample.

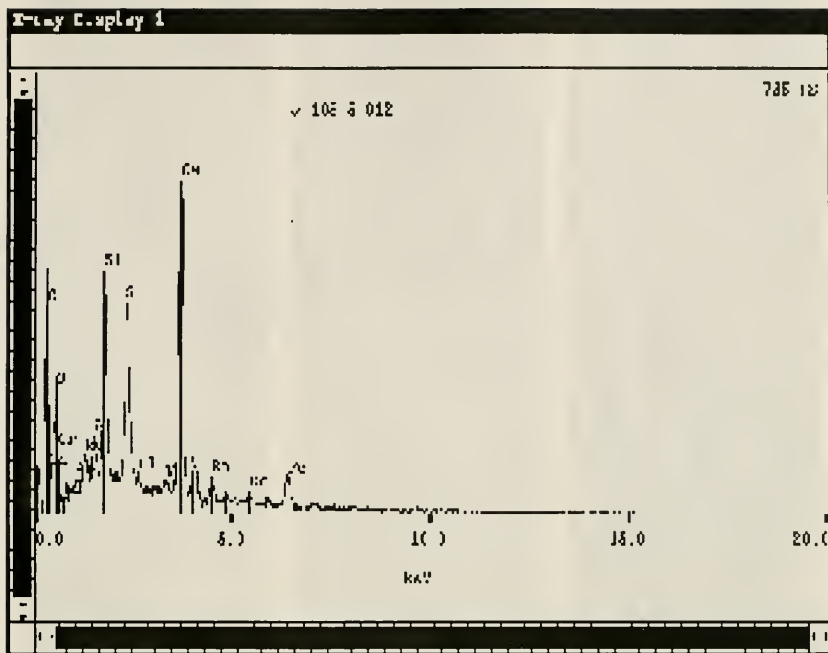
Figure D.3 EDS spectrum of sample 1.03-5 indicating elements present in the original paint layers and the sand-float plaster in the hall.

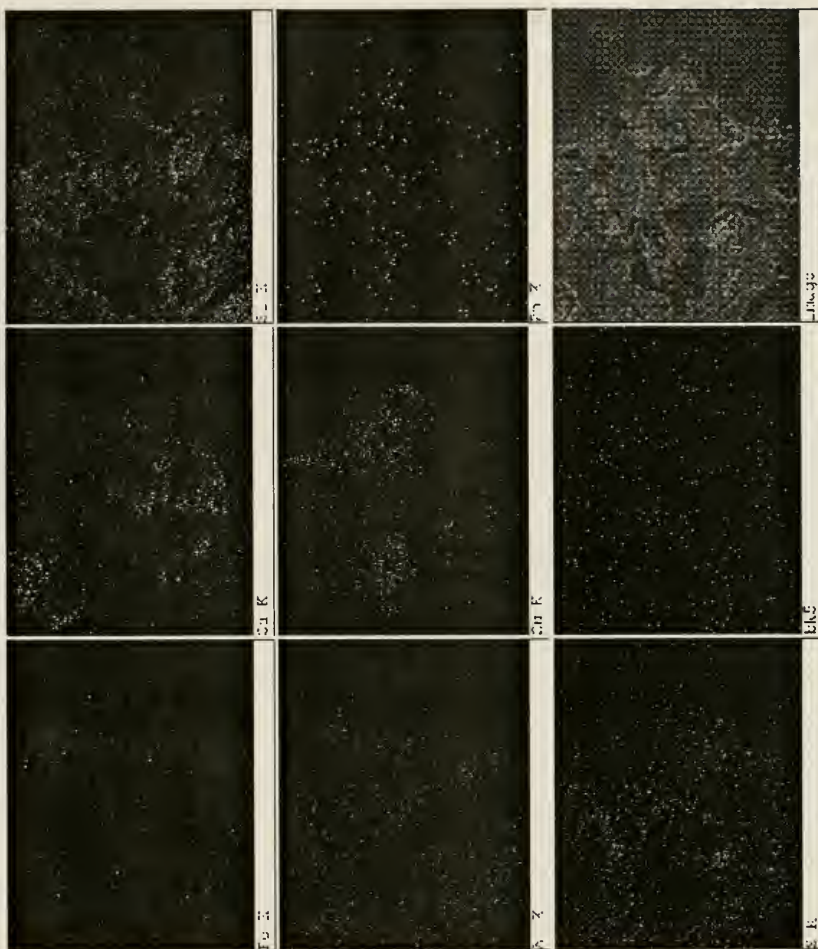
Figure D.12 Electron dot map of sample 1.12-5 indicates the presence of copper and zinc in the bronzing powder and iron in the red paint layer in the dining room. Iron is suggestive of burnt sienna.
